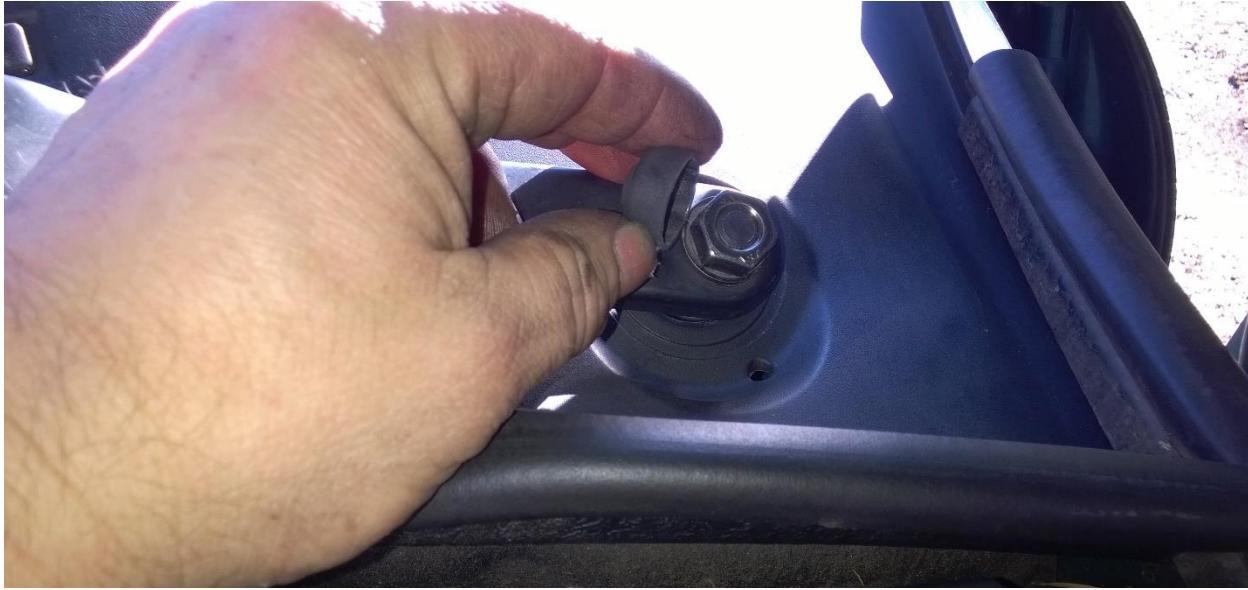
Pop the hood and remove the plastic caps on the wiper arm nuts. They just pull off.

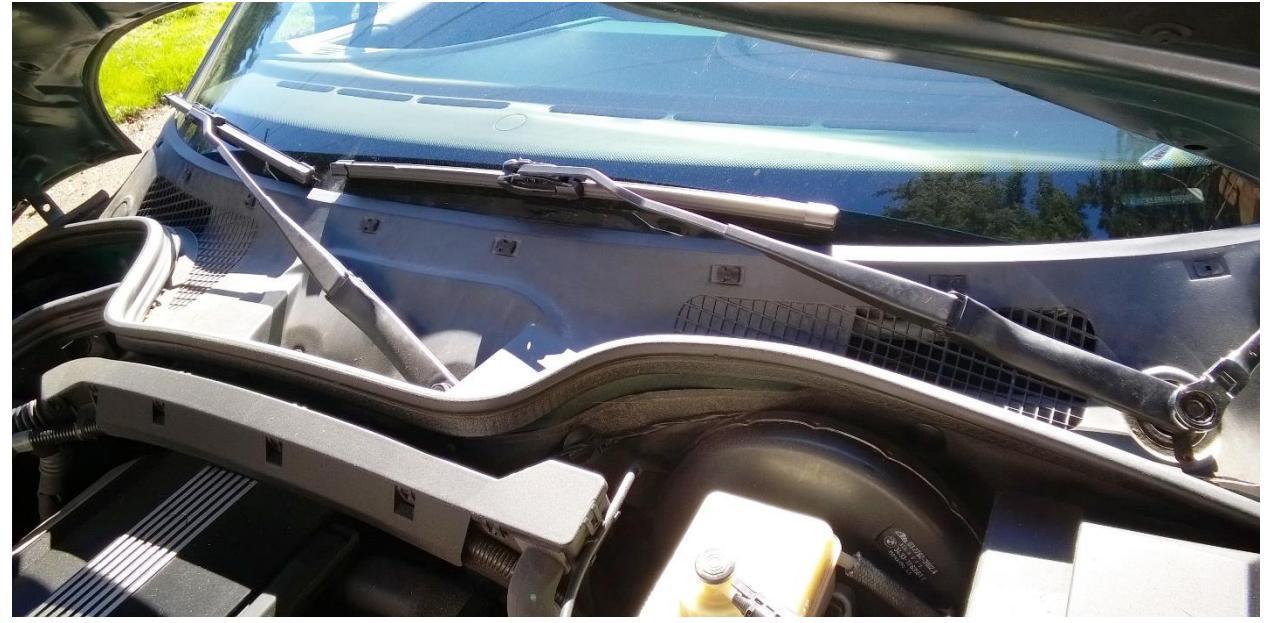
Make note of the position of the wipers so you know where to position them on reassembly. Remove the two nuts securing the wiper arms. You'll need a 16mm wrench.

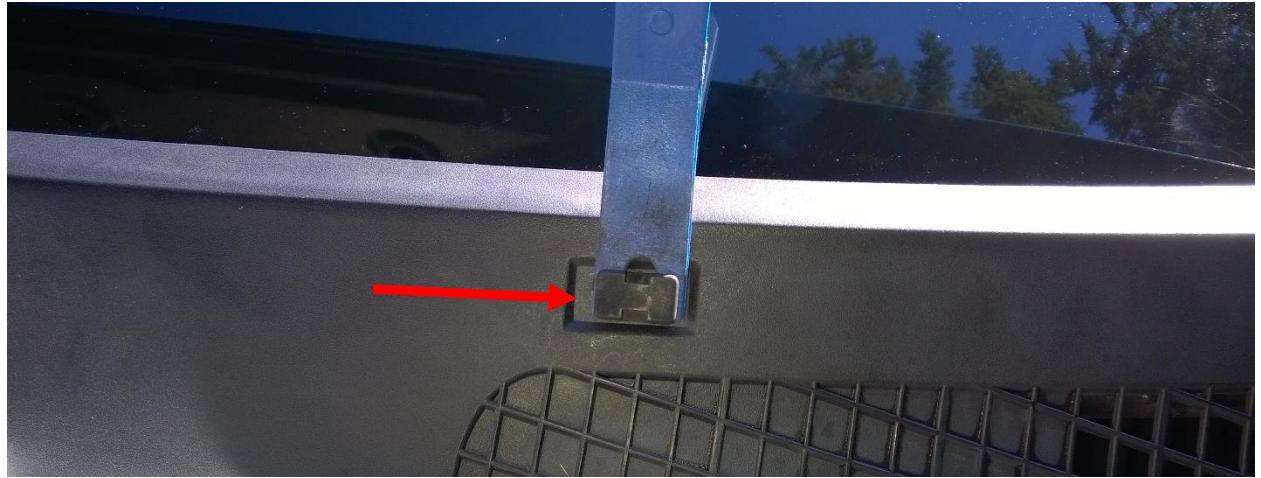
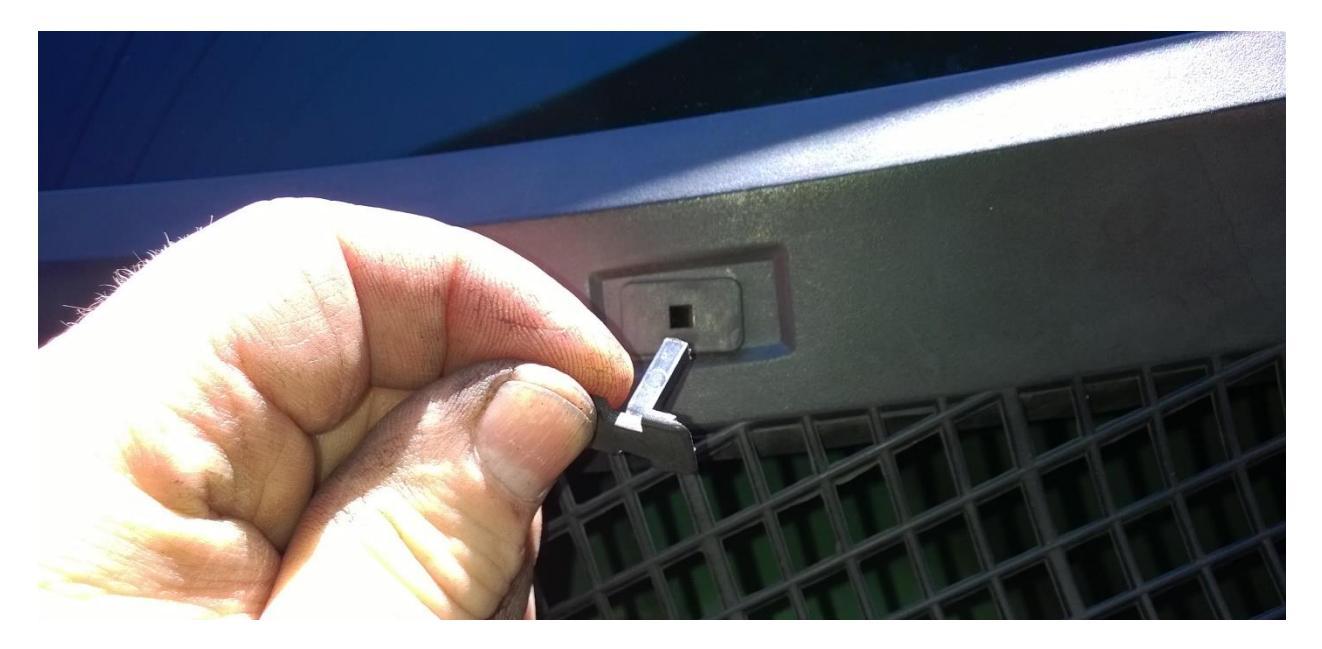
Pry the pins out of the cover retainers.

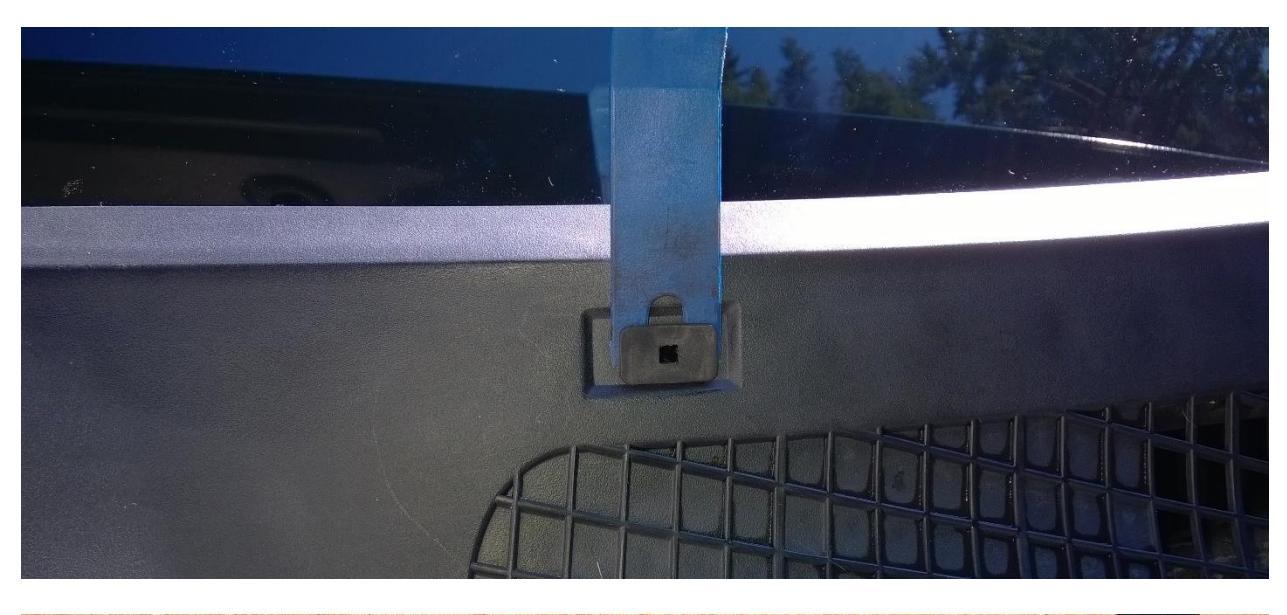
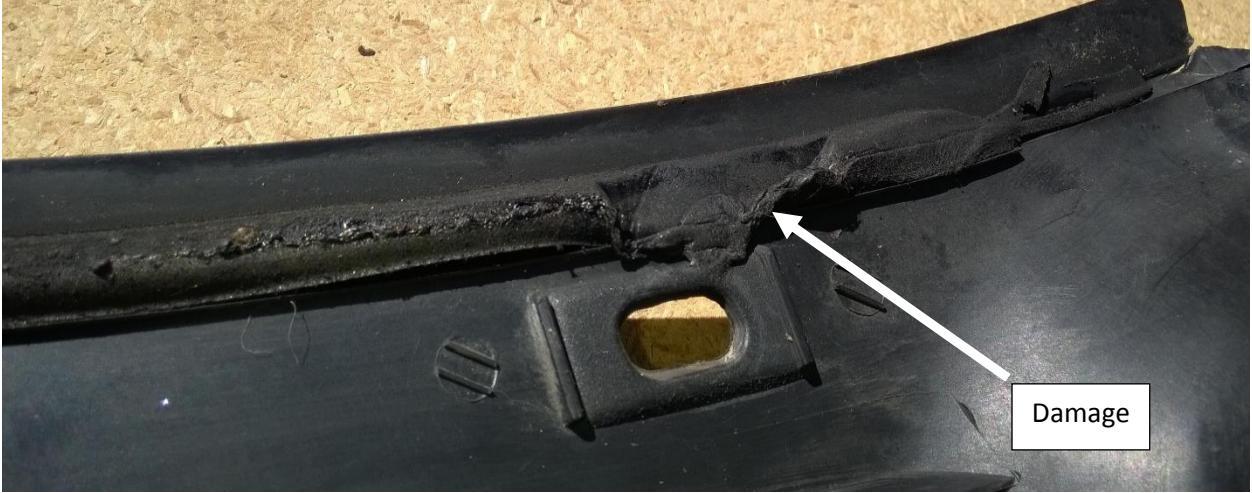
Pry out the cover retainers. Do this from the top of the cover. Use the blade of your pocket knife to lift it enough to get the pry tool under the fastener. I wedged my pry tool under the cover in a couple places only to find later that I damaged the seal under the cover doing so.

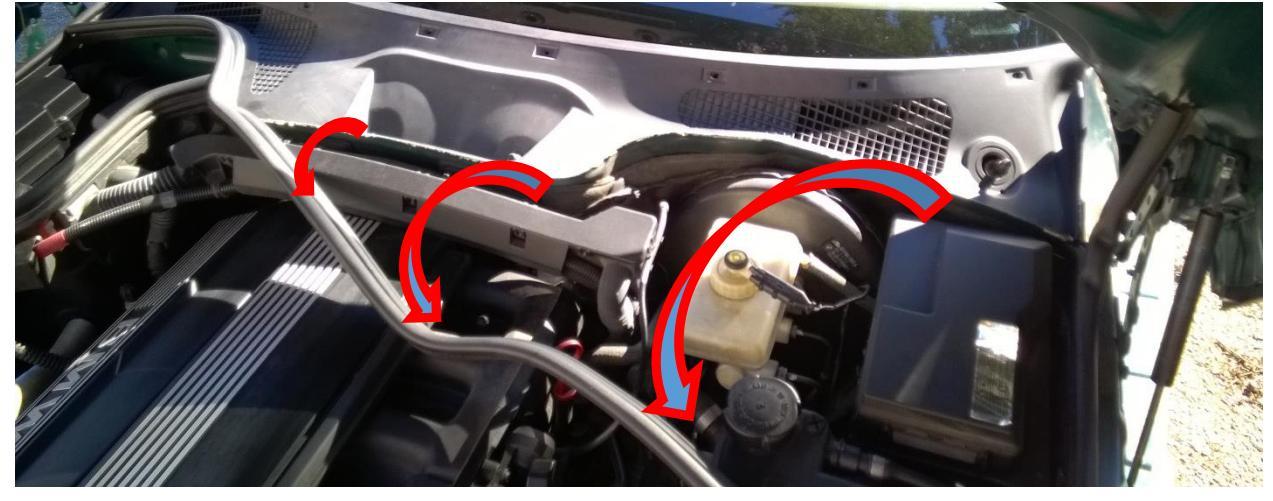
Remove the cover. I had to pull part of the bulb seal off in order to lift the cover off the wiper posts.

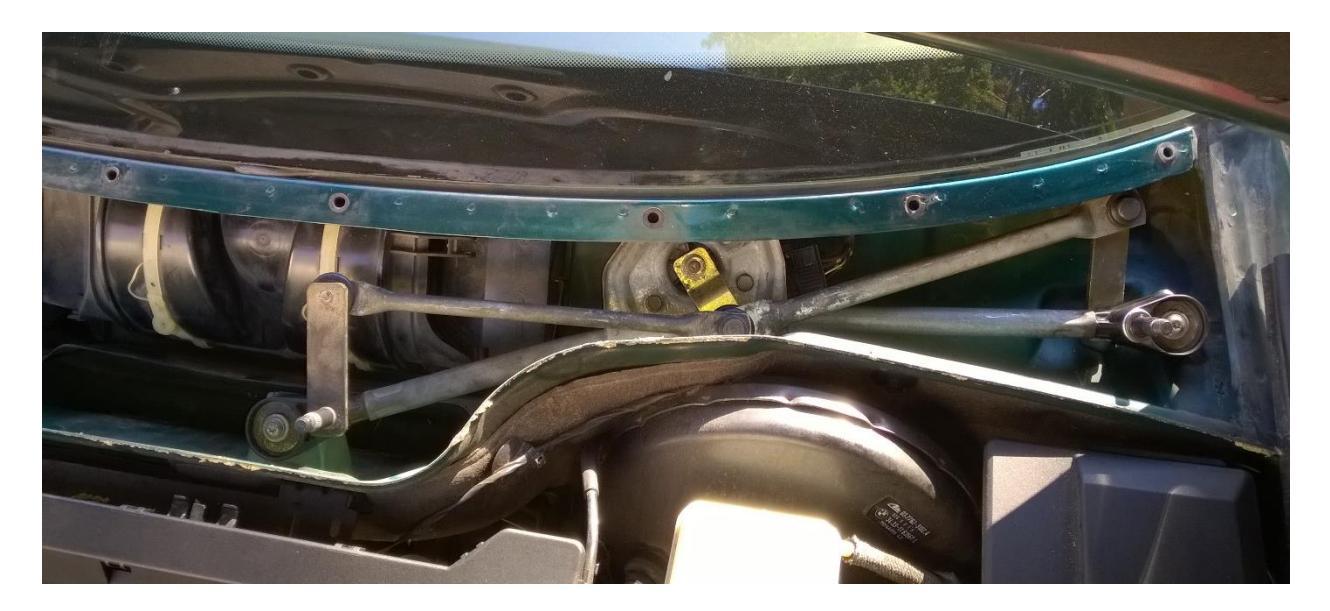
Make note of the positions of the wiper linkage for ease of reassembly.

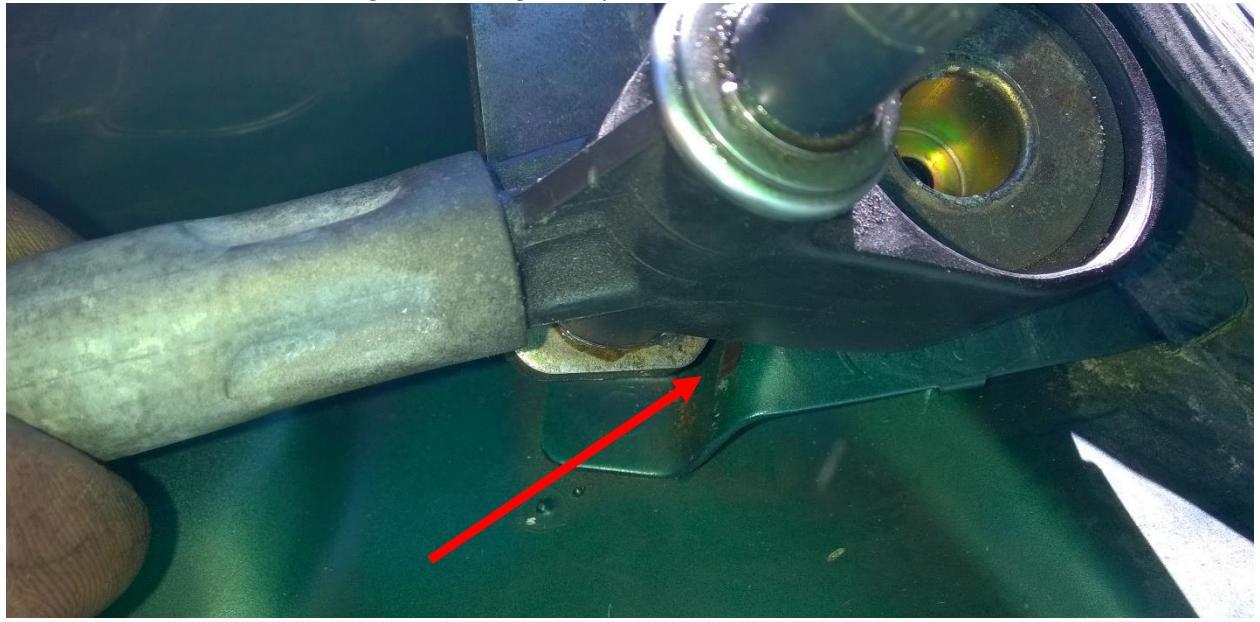
Check for clearance between the left side (driver's perspective) wiper arm and the mounting bracket. This is where mine was rubbing and causing the squeak.

If you had rubbing between the corner of the drive arm and the mount bracket, now is the time to fix it. I ground the corner off the drive arm to get a more generous radius. To prevent rust, I painted the area where I ground the plating off the drive arm. Notice in the photo below, the radius on the upper corner of the arm is larger than the lower corner of the arm.

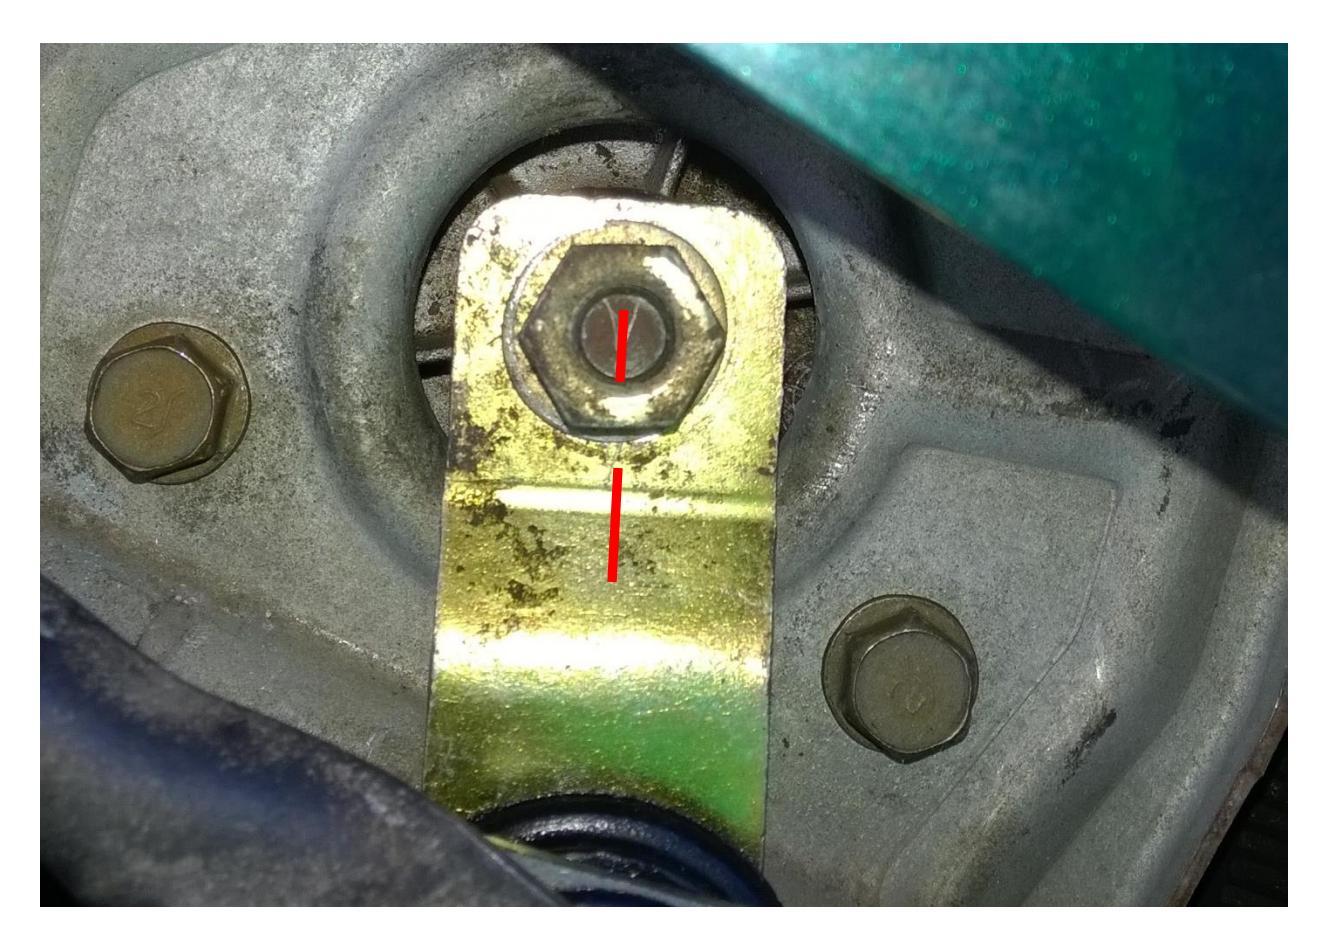
I'm not sure it's necessary but I put a mark on the wiper motor shaft and drive arm so that I could put them back in the same alignment. Remove the nut and wave washer retaining the drive arm to the motor shaft (13mm socket).

Place the linkage back into the compartment. Attach the linkage to the motor gear box with the three screws. Line up your marks on the motor shaft and drive arm. Reinstall the wave washer and nut on the motor shaft.

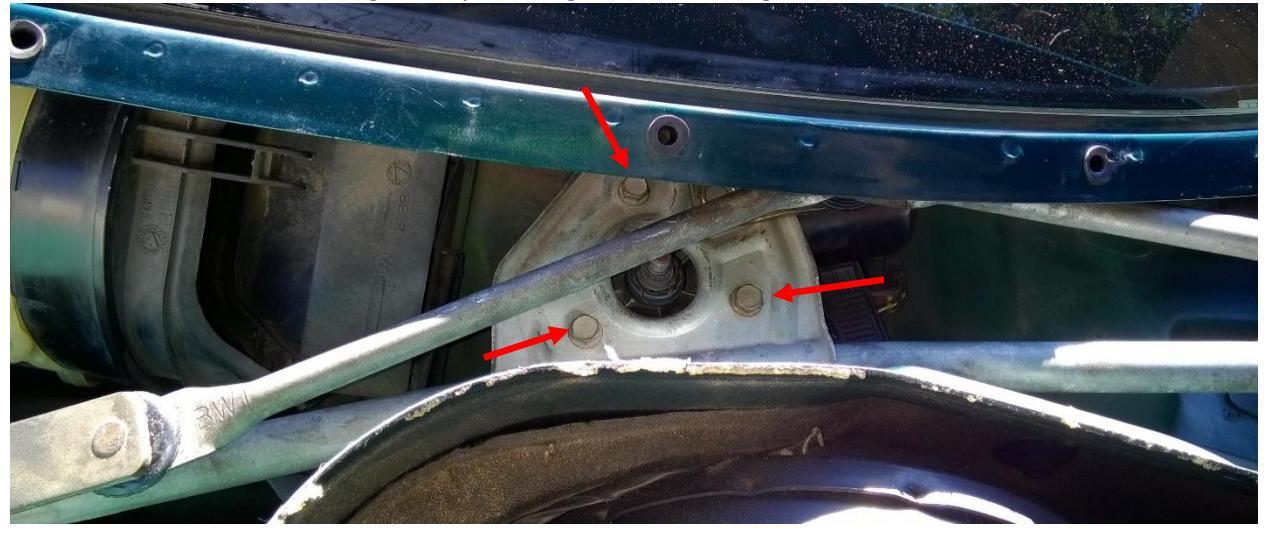
Remove the 3 screws attaching the wiper linkage to the motor gearbox (10mm wrench).

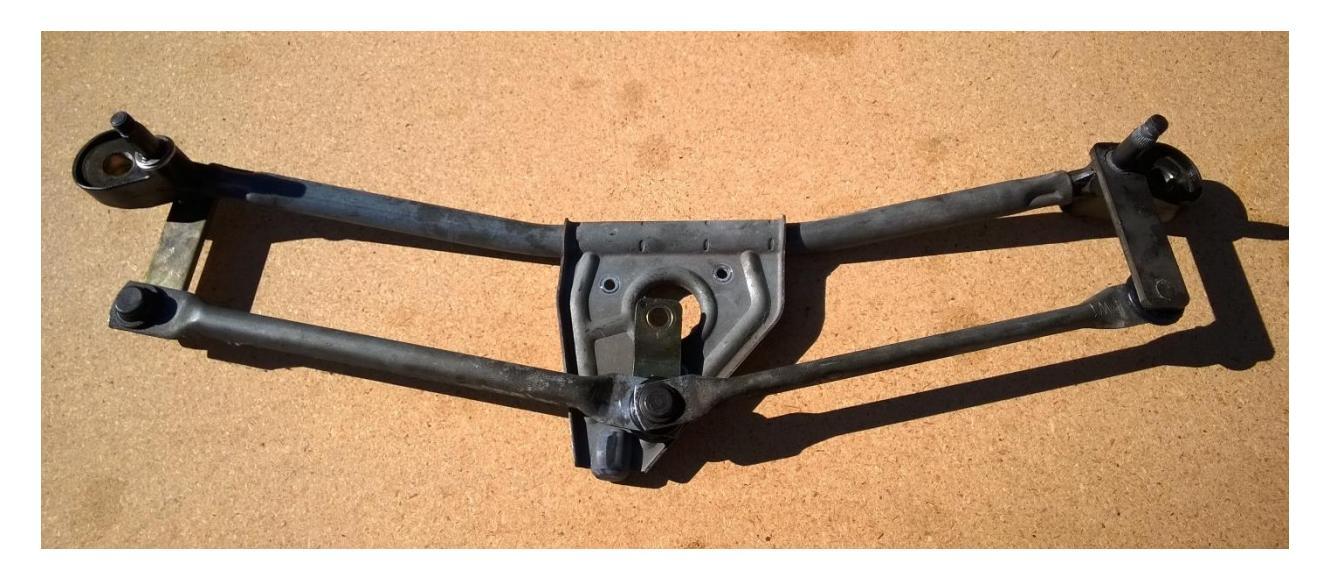
Remove the two Torx head screws securing the ends of the wiper linkage. Lift the linkage out.

Reinstall the two Torx head screws attaching the linkage to the mounting brackets.

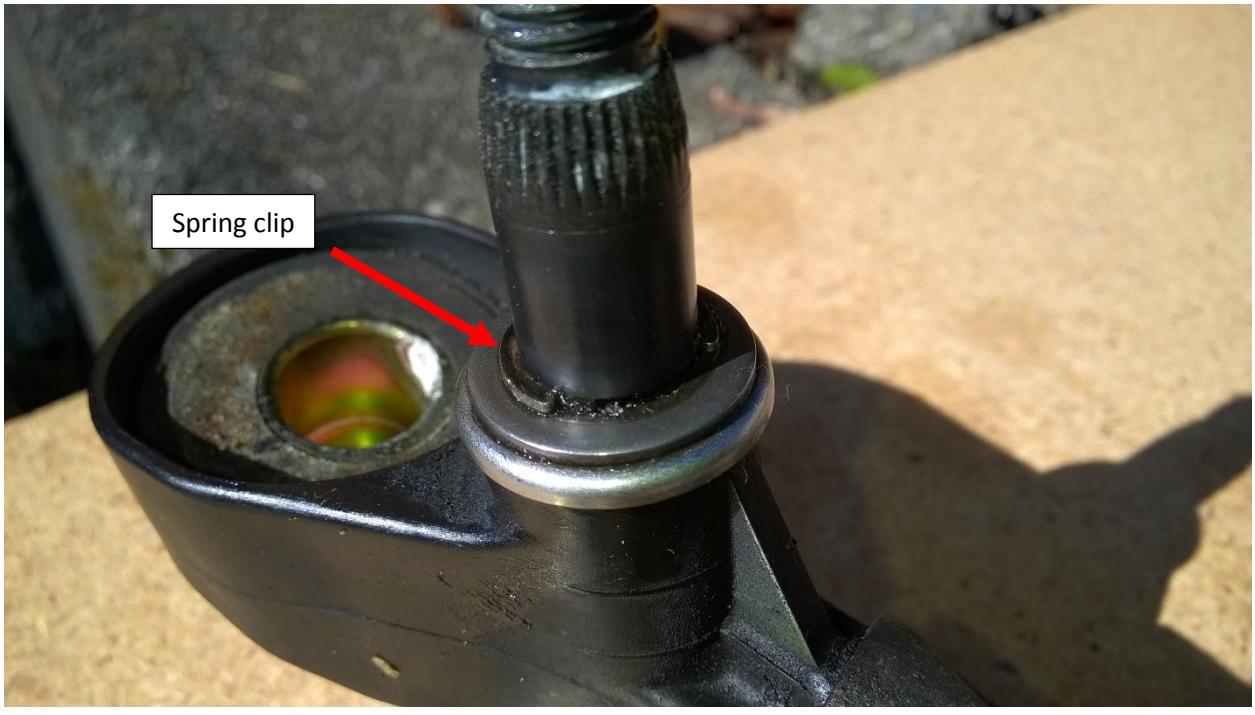
Remove the spring clips securing the linkage arms to the pivot points. Careful to not launch the clip into oblivion.

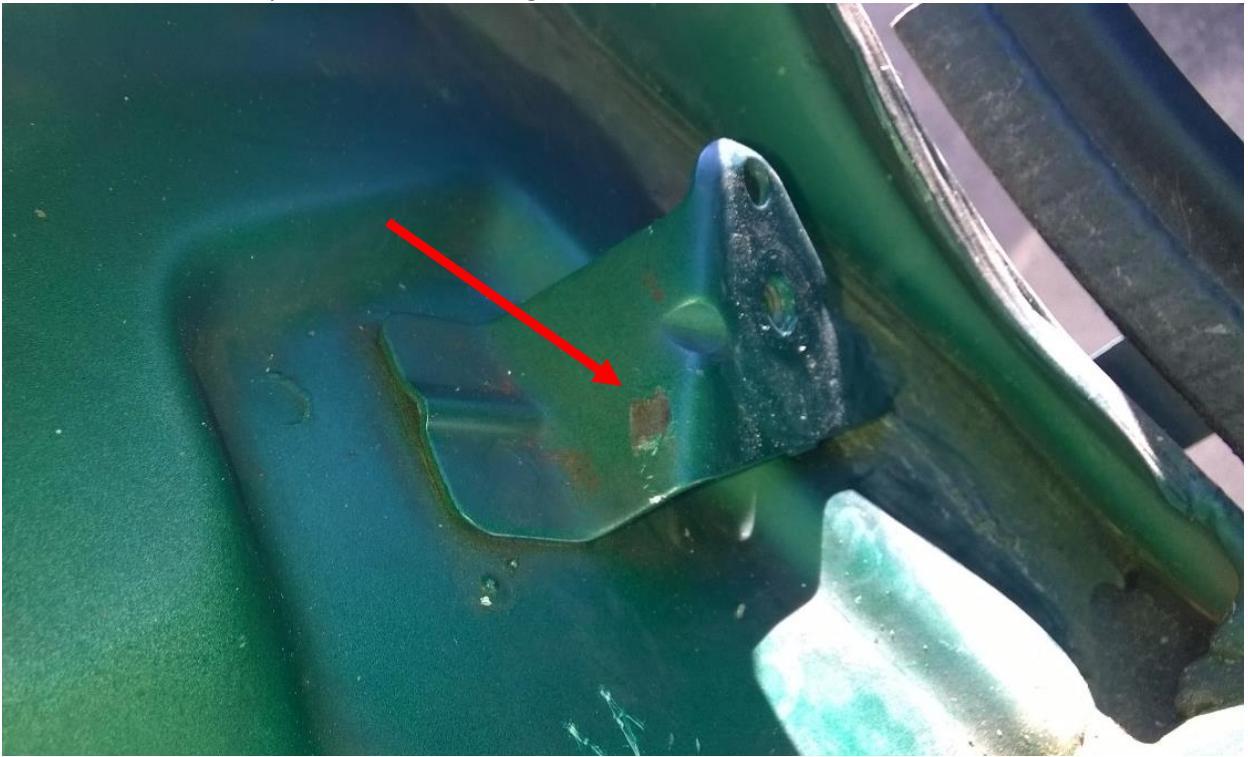
I also repainted the spot on the mount bracket where the paint had been rubbed off. You can see in the photo below, where the arm was rubbing on the mount bracket. I wonder if the bracket was slightly under bent before they welded it on, causing interference?
